# 2024 Year-End Report

## FOREST FIRE LOOKOUT ASSOCIATION

Northwest Montana Lookout Association (NWMTLA) – Local Chapter  
MONTANA / IDAHO NORTH CHAPTER

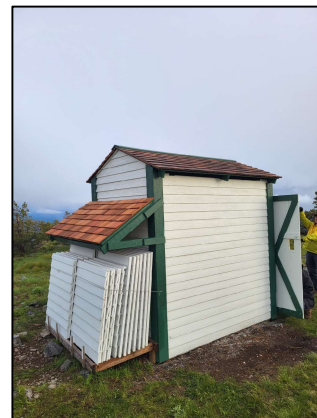
## McGuire Lookout

The McGuire Lookout project focused on upgrading the shed built in the 80's. No work was done on the lookout this year, but the support shed needed some attention. The shed covers an old steel tank that once housed batteries for a radio repeater and other electronics. The shed is now used for storage to support the lookout which is in the rec.gov rental program. This year a roof was built on the back side of the shed to better protect the lookout shutters when the lookout is open to the public for rental. NMLA volunteers, Barb Hvizdak, Helen Tyree, Jim Peacock, Chuck Manning, Forest Service personnel, and the Youth Conservation Corp helped on this project which covered a total intermittent span of four days. -NMLA

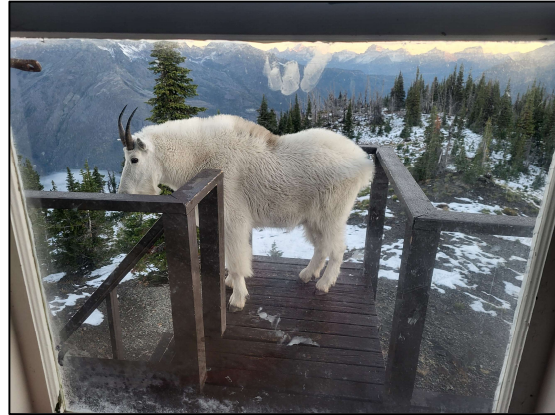
### **MT Brown Lookout**

The Mount Brown Lookout in Glacier National Park project was an overnight project to wrap-up a project which couldn't be completed in 2023 due to the cure time for the window glaze. Chuck and Nancy Manning hiked to MT Brown to complete this task. They spent the night and were awakened early next morning by a mountain goat on the catwalk checking out who was occupying "his" lookout. -NMLA

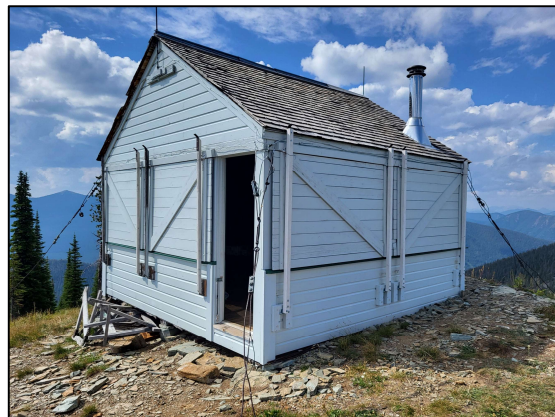
### **Mount Wam Lookout**

The Mount Wam Lookout rehab project is close to being completed. This year, the project dates were changed, which affected the intended task outcomes on this project. Mark Miller, Chuck Manning, Barb Hvizdak, KNF Forest Service personnel, and the Youth Conservation Corp all committed one day to this project. Next year, several days should be set aside to finish installing the shutter braces, repair the vandalized shutters, do some touchup painting, and dispose of the discarded lumber under the cab to mitigate rodent nesting. Installing new roof shingles and ridge cap should be addressed in the near future as the Wx has eroded the shingles by about 50%. -NMLA

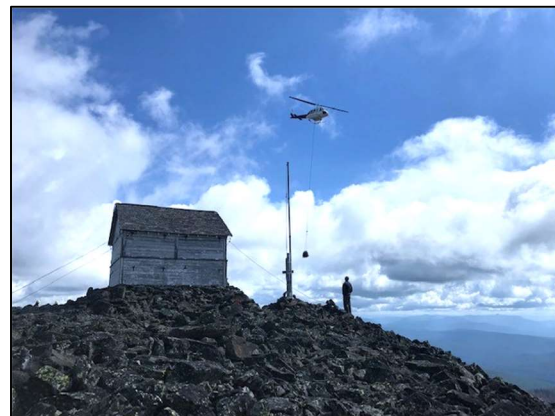
### **Northwest Peak Lookout**

Northwest Peak Lookout is located in the Northwest Peak Scenic Area in the Northwest Corner of Montana. The scope of this year's work on Northwest Peak Lookout consisted of removing the windows and inserting plywood panels to protect the lookout over the winter. This phase of the project was completed by NMLA volunteers Peter Kitts and John Zardis with the help of several Forest Service employees and a Youth Conservation crew. The windows were helicoptered out by a coordinated effort of the KNF Helitack crew and other fire personnel. Also, a pre-project assessment was conducted to determine the sequence, materials, and costs of tasks that need to be addressed in 2025 was conducted by Peter Kitts and Chuck Manning. - NMLA

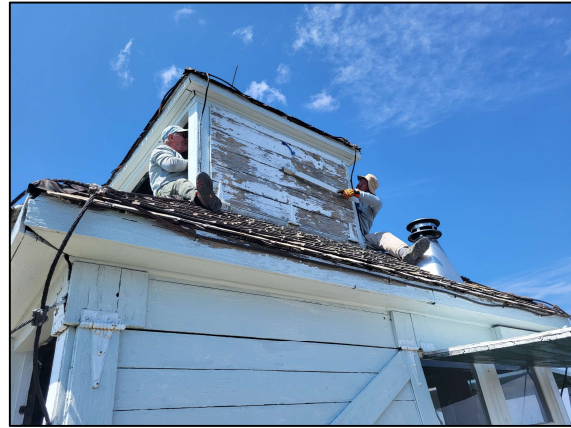
### **Stahl Peak Lookout**

Stahl Peak lookout, a cupola style lookout, is perched atop a precipice overlooking the Ten Lakes Wilderness Study Area east of Eureka Montana. A pre-project assessment was conducted in advance of this project to determine what supplies were needed to be packed in for the 5-day project. With the help of the Northwest Montana Backcountry Horsemen to support this project, completed tasks consisted of repairing the shutters to better protect the lookout windows, replacing two windows in the cupola, and scraping and painting the entire exterior with two coats of paint. Mark Gunther, Chuck Stearns, Kira Powell, Chuck Manning, and Barb Hvizdak were instrumental in completing all phases of this project. A major rehab of Stahl Peak Lookout is tentatively planned for 2026. -NMLA

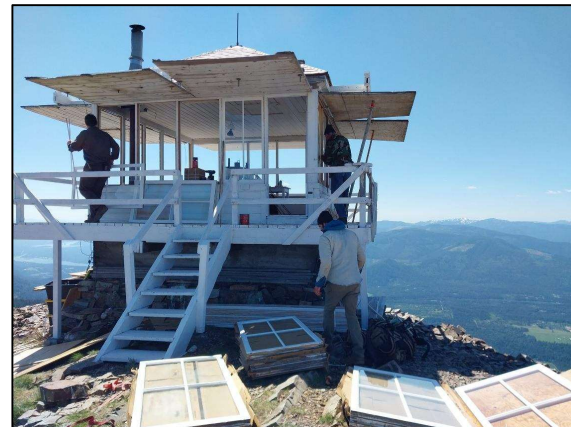
### **Star Peak Lookout**

The Star Peak lookout restoration project started in 2023 through the support of GAOA funding. In 2023, the windows were removed and flown off the mountain to be rehabbed at the Murphy Lake Ranger Station on the Ksanka Ranger District and a new roof was installed. During April and May of this year, NMLA volunteers removed and reset (glaze in) the glass and painted all 19 windows. In June of this year the KNF Helitack crew flew the windows back up to the lookout and helped with the installation. During the summer, Bob Lambrecht, Seth Lambrecht, Katherine Maudrone and Klare Matthew installed new shutters (built on-site in 2023-24), repaired shutter outriggers, painted the lookout exterior, interior, and interior floor. 2024 leaves the lookout in a restored condition. This project wouldn't have happened without the dedication of NMLA member Bob Lambrecht who personally took it upon himself to oversee and manage it's success and the packstock support by Cabinet Back Country Horsemen member Jeff Grotjohn. -NMLA

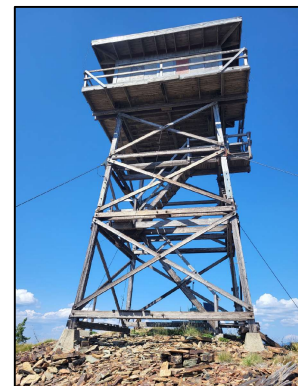
### **Berray Lookout**

The current Berray Mountain Lookout was built in 1965. It is an R-6 flat cab style resting on a 30' treated timber tower. Berray lookout overlooks the lower Bull River drainage and west into the proposed Scotchman Peak Wilderness. The assessment was conducted to scope out findings for future stabilization and restoration efforts. The deferred maintenance has reached a point where the cost-effective measures for restoration are becoming questionable, and the lookout structure access safety concerns will only escalate. A new roof membrane was installed in 2017 to help defer both interior and exterior damage. Chuck Manning and Troy Denman along with Cabinet Ranger District personnel conducted this assessment. -NMLA

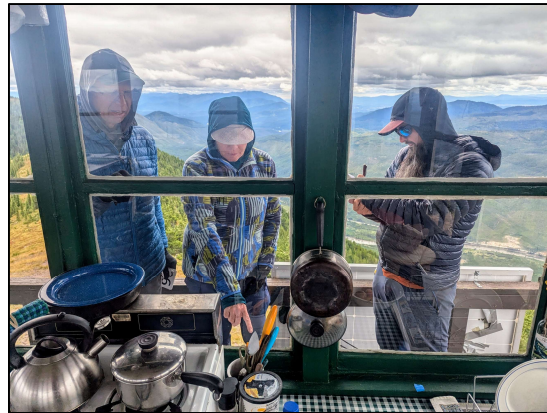
### **Huckleberry Mountain Lookout**

Huckleberry Lookout overlooks the North Fork of the Flathead River and the Camas drainage in Glacier National Park. This assessment was conducted to scope out findings for any stabilization and/or restoration efforts. The Northwest Montana Lookout Association conducts a general condition assessment of Huckleberry Lookout every three years in accordance with a Cooperative Management Agreement. Katie Marsonette, Eric Godin and Joe Schmidt conducted this assessment in August. -NMLA

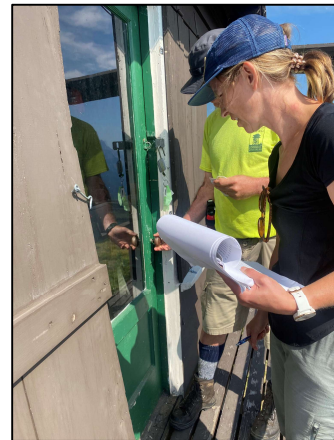
### **Loneman Mountain Lookout**

In August of 2024, a comprehensive assessment of the historic Loneman Fire Lookout situated in the Nyack area of Glacier National Park, was conducted by Amanda McIntosh, Mark Miller and Molly Tingley. The assessment revealed that while the interior of the lookout is in good condition, the exterior included weakened and rotting catwalk and worn paint. The findings underscore the need for preservation work to ensure the tower's stability and safety, while maintaining its historical and functional value as a critical piece of the park's fire management history. – Molly Tingley

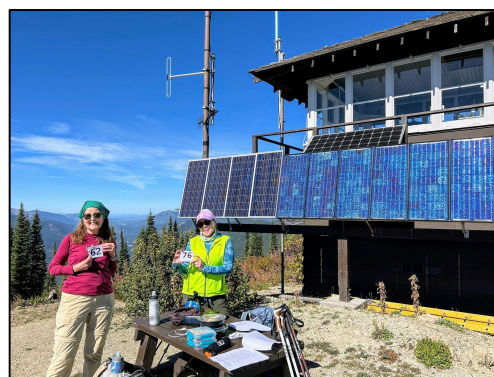
### **Scalplock Mountain Lookout**

Scalplock Mountain Lookout, built in 1931, overlooks the Middle Fork of the Flathead River and the Great Bear Wilderness to the west and south. Katie Marsonette, Duane Day and Sabrina Shattles conducted an assessment in September to determine the lookout's general condition and report any urgent repairs that needed to be completed before winter. Several items of concern were reported. Scalplock Lookout is assessed every three years in accordance with a Cooperative Management Agreement. - NMLA
