2025 Year-End Report

Northwest Montana Lookout Association (NWMTLA) – Local Chapter

PROJECTS AND ACTIVITIES:

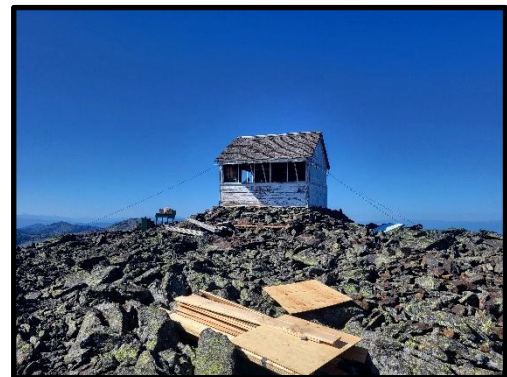
NW Peak Lookout

Northwest Peak Lookout located in the Yaak overlooks the Northwest Peak Scenic Area in Northwest corner of Montana. Perched on a mountain of broken talus this lookout project started last year with the removal of all windows which were blown off and refurbished over the winter by Edd Kuropat and Peter Kitts. The windows and other materials were flown back up to the lookout in June in advance of this summer's project which consisted of stabilizing all four wall that had major structural deficiencies, the installation of several new shutters that were built in 2018, and the start of installing the ceiling which was removed in 2017. This year's onsite NMLA volunteers were Peter Kitts, Mark Gunther, John Zardis, Chuck Stearns, Randy Beachman, and Chuck Manning. A special recognition must be given to the Cabinet Back Country Horseman for their support in helping transport tools and supplies to a base camp located just off the talus slope. Also, a huge thank you must go out to the Three Rivers Ranger District and the Kootenai National Forest Helitack Team for their ongoing support.

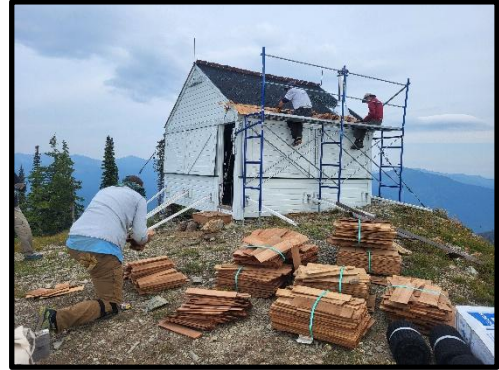
MT Wam Lookout

Mount Wam Lookout, built in 1931, is one of the last gabled L-4 lookouts that sits atop a 7,121' peak in the Whitefish Range and was staffed as a fire lookout in the 1950s. Located in the Ten Lakes Scenic Area and along the Pacific Northwest Trail, this lookout is open to the public and often used as a shelter. This summer's project focused on reroofing the lookout which took place in mid-August. The new cedar shingle roof was funded through the Great American Outdoors Act and installed by NMLA members, Mark Miller, Barb Hvizdak, Rory Trimbo, Steve Glow, and Chuck Manning. Several Forest Service employees also helped tackle this project and a huge THANK YOU must go out to the Northwest Montana Back Country Horsemen who transported supplies and scaffolding back and forth to the jobsite.

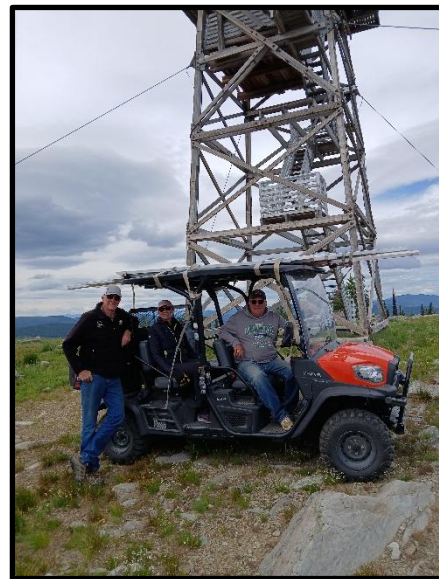
Big Creek Baldy Lookout

Long-term work in progress. Work has been occurring on Big Creek Baldy with a new roof, lightning protection and securing the hatch to the roof with Troy Denman as the lead. In addition, the Libby Ranger District crew of Micha and Zach helped with securing landings and new handrails at the landings. Additionally, a new wire mesh was installed for safety and stability on the catwalk. Needs and materials were prioritized with NWMTLA, and all materials were purchased funds in the challenge cost share with Libby Ranger District.

This year the volunteer crew did get a new railing on the catwalk. This also improved stability and safety for those visiting this great lookout. A special thank you to the crew for hanging in there and the ranger district for their patience in working with us!

There will be future need on this lookout for scraping and staining/painting.....

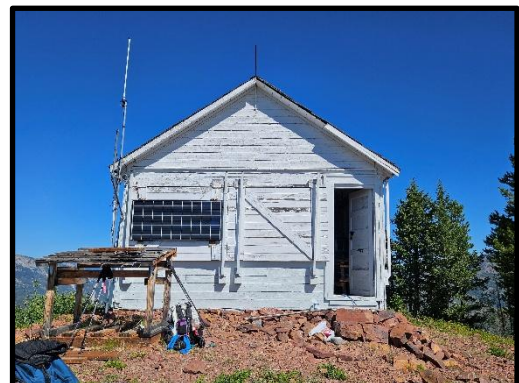
Mud Lake Lookout

The crew hiked into the Bob Marshall Wilderness, leaving from the Meadow Creek Trailhead. The first day they hiked 12 miles to the Blac Bear Cabin. The second day they hiked 8 miles and stayed at the Salmon Forks Cabin. On the third day, they made it to Mud Lake Lookout. A 2.5-mile hike one way with lots of blowdown to navigate. This required a ford across the South Fork of the Flathead River in both directions. The team did the same itinerary on the way back to Meadow Creek Trailhead. The crew enjoyed the wilderness experience, worked well together, had an enjoyable time overall and especially when some FWP folks joined us at Black Bear on night one with their engaging banter, and Kira graced them with her guitar and singing talents.

In addition to completing the assessment, the crew also had packed in the needed paint/stain to put on the window glazing that was an outstanding need. The painting was completed.

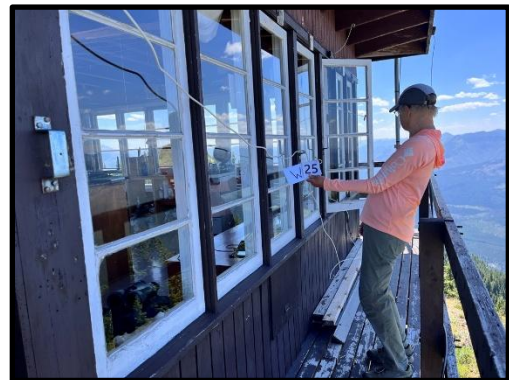
Spotted Bear Lookout

The lookout has been wrapped a few times for wildfire protection. These efforts are greatly appreciated so that the lookout has not been harmed by fires. There are many needs identified – including window glazing, painting, some flooring, and potentially a new outhouse or stabilizing the outhouse.

Two windowpanes need immediate replacement. Measurements were taken and new panes and glaze compound were delivered to Spotted Bear to be packed up and installed to better winterize.

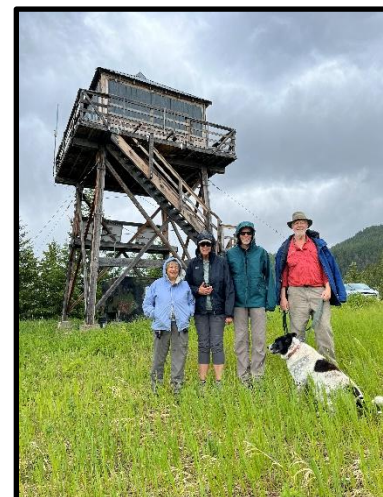
Located in the Swan River drainage near Goat Creek in Northwestern Montana, Little Napa Lookout sits at 4448 feet and was built in 1977 to replace a school bus with an attached cupola that was used from 1969 through 1976. In 2017, the NWMT Lookout Association participated in a major project to replace stairs, catwalk, and improve cross-bracing. This year's objective was to assess the feasibility of improving/stabilizing the lookout so that it can safely function intermittently for staffing in times of high fire danger or predicted lightning. Thank you volunteers Cathy Calloway, Doug Berglund, Barb Penner, Steve Penner, and Beth Hodder along with DNRC Swan Unit staff for conducting this assessment.

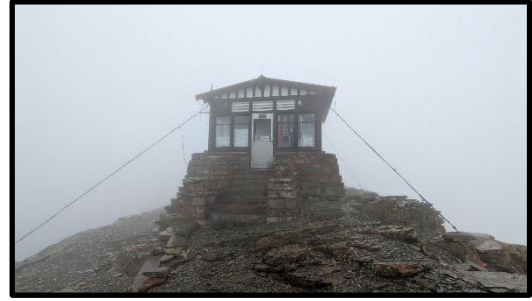
Swiftcurrent Lookout

The Swiftcurrent lookout is a two-story, square plan structure constructed in 1936. The construction of this lookout provided one of the final links in a system of lookouts that minimized the destruction by fire of the park's scenic qualities. This summer's project involved a condition assessment. The Swift Current lookout is in satisfactory condition with no major defects or rehabilitation issues seemingly present. Ongoing maintenance tasks appear to be required but were generally minor in scale.

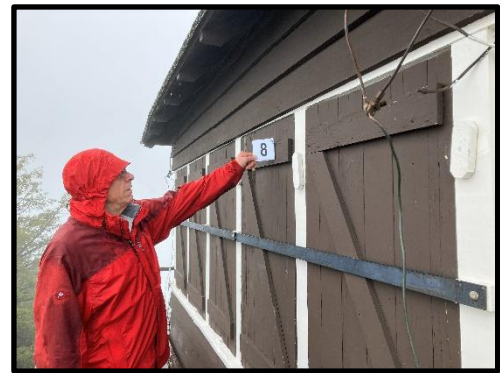
Agger Lookout

Agger Lookout, build in 1929, is a two-story, square log-framed interior building with a cedar-shingled pyramidal hip roof and lapboard siding. Ironically shortly after its completion the lookout was destroyed by fire. The park service secured funding and rebuilt the lookout, identical to the first, in 1930. While the Agger lookout is not currently staffed, it is still significant because it illustrates an important aspect in the management and conservation of timber resources in Glacier National Park. This summer's project involved a condition assessment which found the lookout to be in good shape with primarily minor cosmetic repairs needed.

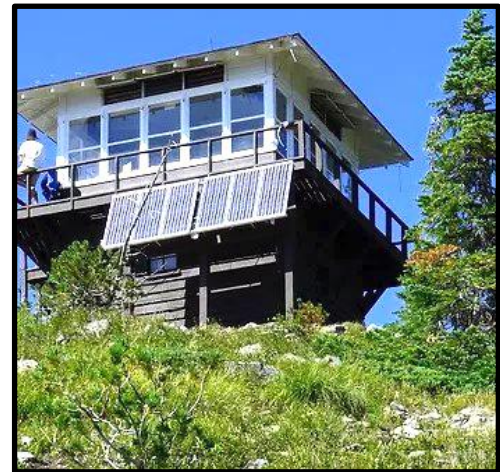
Numa Ridge Lookout is a standard wood frame, 14x14-ft house set on a 10-ft tower with catwalk. Numa Ridge lookout is one of several similar buildings constructed in Glacier National Park between the late 1920s and the early 1940s to protect park lands from the always critical threat of fire. This summer's project involved a condition assessment which found the lookout's exterior in poor condition with structural repairs and replacement needed on the foundation, catwalk/railings, stairs/railings and some of the siding. The entire exterior is in need of scraping and painting while the interior is in overall good shape with the exception of the door which is in need of repair.
